Ignition Problems

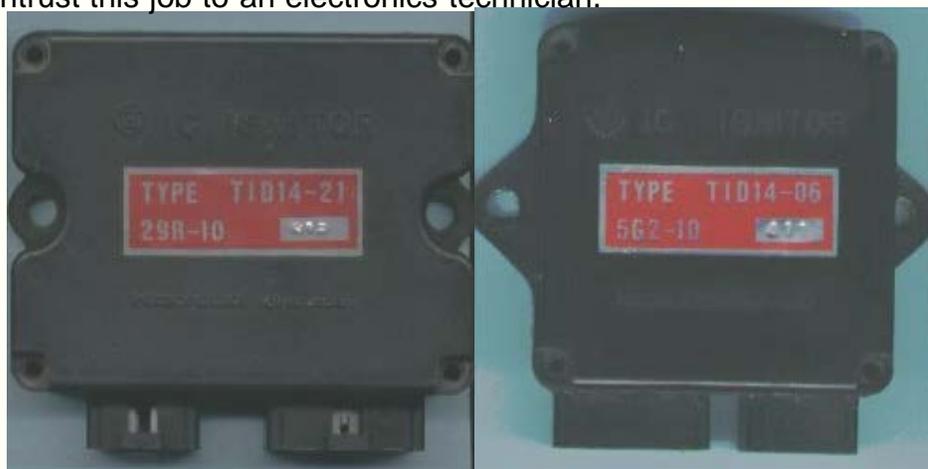
Later type from a 1983 XJ750EII Older type as used on my 1985 XJ750P (Remember the XJ750P is actually based on the 1981-82 Seca and was used as a way to get rid of new old stock parts)

There are a number of different TCI's used on XJ's. Here the later design on the left has been highlighted for part identification and the older design is on the right.

There are two basic types that I have found, In my experience they will interchange BUT they originally came out on bikes with different resistance pickup and ignition coils. If you need to interchange the two types it must be your call.

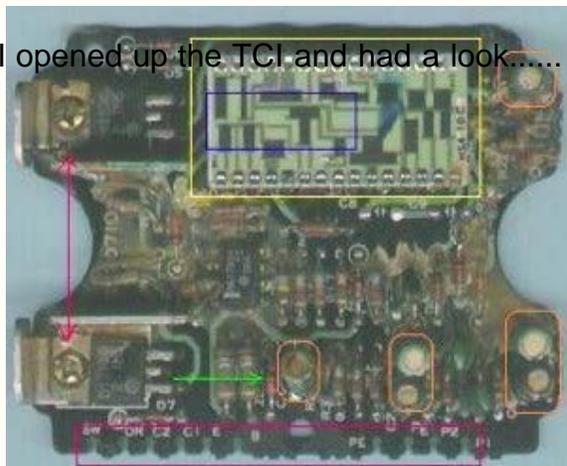
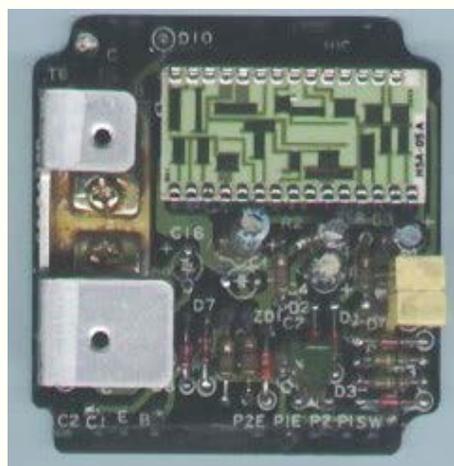
Inside the left hand unit there is a Printed Circuit Board (PCB'd) that is held in by 3 screws and a line of soldered connections down the edge (red box) that connect the board to the sockets where the wiring plugs into the case. The right hand one has the edge solder and two screws through the back of the case.

To remove the PCB'd from the case you must first de-solder the edge connections using a fine tip soldering iron (blunt pencil tip about 40 watts is ideal) and a solder sucker like this....

To de-solder you must melt the connection with your iron and suck the solder away with the solder sucker thus releasing each connection.

Once the solder is removed and you have removed the screws you may also have to GENTLY prize the PCB'd out of the case.

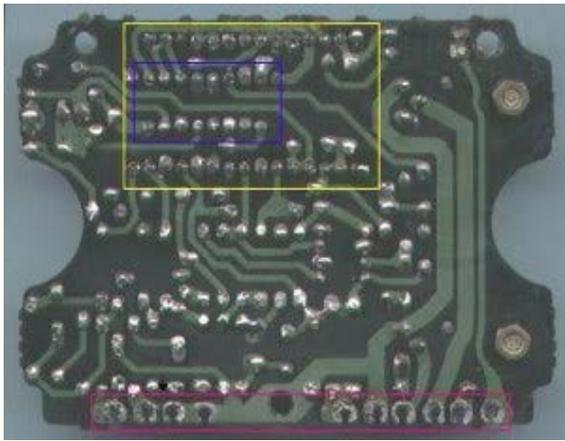
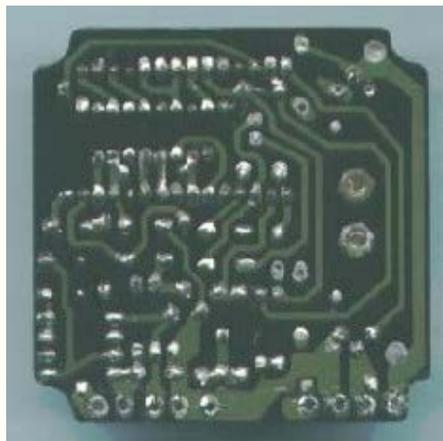
There are a few things to note.

Firstly after adding the components to the board in the factory they have sprayed it with an electrical lacquer to seal it against water and then poured a contact adhesive glue over the component side to dampen vibration that can break off the legs of the taller components. Both of these can be removed without damage to the PCB'd by soaking an old toothbrush in acetone and gently scrubbing the PCB'd clean.

Also of note is the ceramic etched PCB (yellow box) mounted up on legs over the top of some other components including the main Integrated Circuit (IC in blue box) and the fact that there are tracks on both sides of the PCB with links passing through with many of the component legs.

There are also six electrolytic capacitors (orange circles) on the board. The sizes of these are

There have also been cases I have heard of where the main power transistors (red arrow) mounted to the heat sinks can fail resulting in the loss of ignition to the two cylinders fed by each transistor. I have not as yet run into this problem but I understand there is a replacement available.

Also the 12 volt Zener Diode (green arrow) has been known to fail. This causes total failure of the unit, but is also an easily available cheap component. This is probably caused by incorrect jump starting of the bike from another battery. ALWAYS make sure the key is off before connecting jumper leads as the spark created can "spike" the electronics on the bike damaging them.

They are easy to fix, simply reflow the solder with your iron and add a small amount of fresh resin cored solder. If it is a really bad joint it is wise to remove all the old solder with your sucker and renew it with fresh solder.

Now the bad news, On my TCI there were some dry joints on the main IC under the ceramic PCB'd that could only be got at by removing the ceramic PCB'd from the main PCB'd.

I managed this by heating the solder from the component side of the main PCB'd and sucking the solder through the holes from the track side with the solder sucker. Again, care must be taken to do each joint as fast as you can or too much heat can damage the PCB'd.

Eventually the ceramic PCB'd was out of the way and it was a simple matter to reflow the joints on the main IC and refit the ceramic PCB'd.

This type of capacitor is prone to failure from age, heat, and vibration and should also be replaced. They are only a few cents each. Note that they are a polarized component and must be fitted the correct way around so take note of the (-) sign on the side of each capacitor and the (+) signs printed on the PCB'd. Some of the capacitors have there wire soldered on both sides of the board. They can be difficult to remove without damaging the tracks. Again I was able to suck the solder through the hole to the other side with my solder sucker. I found that by pre-tinning the legs of the new capacitors the solder would flow through the hole and give a good connection on both sides of the PCB'd

The only thing left to do is to re-spray the PCB'd with lacquer to seal it and add some contact adhesive to the taller components to stabilize them against vibration. The Lacquer I used was CRC Plasticote 70. It took a while to dry but seems to work well. The glue I used was a simple garden variety contact glue from the local hardware store.

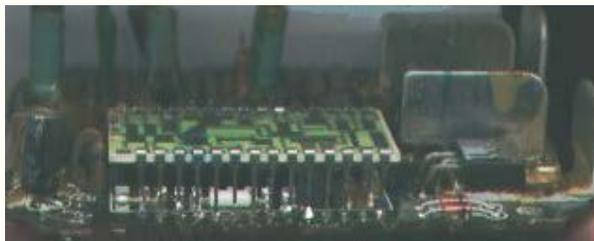
The ceramic PCB is very delicate and easily damaged!!

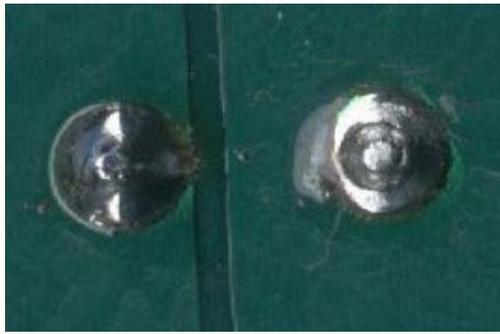
What is a dry joint? A dry joint is one thing, TROUBLE! It is a connection with a high electrical resistance and is often not actually connected firmly resulting in intermittent faults.

On the left is a good joint. It is bright and shiny and smooth. On the right is the curse of any circuit, a dry joint, note the obvious ring around the wire, this is in fact a crack in the solder caused by either vibration or electrical loading resulting in heat. You can also make out the satin finish on the solder as apposed to the bright smooth appearance on the good joint on the left.

A dry joint will often show signs of arcing with charring around the connection but this is normally only on components that are passing a high current (amps).
